RI 9366

Entry Stabilization Utilizing Rib Bolting Procedures

By Dennis R. Dolinar and Stephen C. Tadolini

BUREAU OF MINES

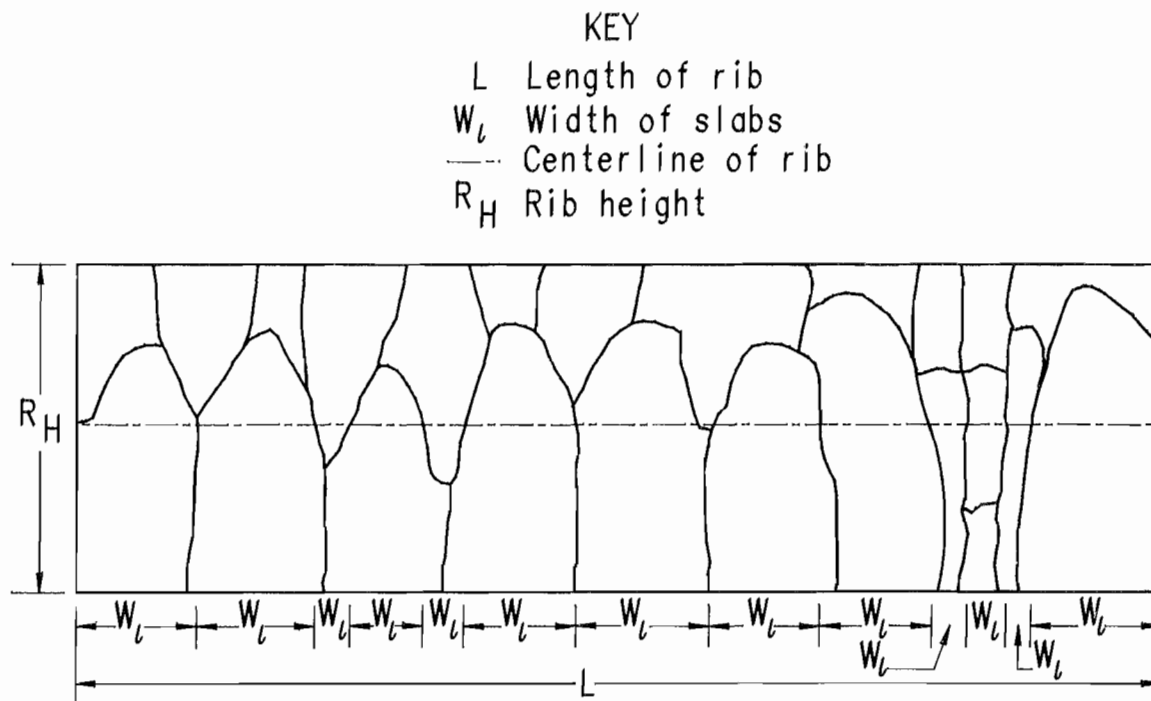
Figure 1.—Relationship between slab width and rib length along center reference line for spalled rib.

Bolts work most efficiently in the retention of a rib when slabs are formed (2). An example of how the amount of rib retained can be determined statistically will be developed for a section of rib where slabs form. An assumption is made that if one bolt intersects a slab, the slab will be retained. For large slabs, such as a rib roll or slabs of coal which weigh more than the support capacity, more than one bolt would have to be applied to the slab (8). Figure 1 shows a section of rib where slabs form along the entire rib length. If a horizontal reference line is drawn down the center of the rib and uniformly spaced support is applied along the reference line, the following equation can be used to determine the amount of rib retained for a given bolt spacing.

An example of the rib retention calculation can be developed. For a 30-ft section of rib, if slabs form with widths along the support line of 6, 5, 5, 4, 3, 2, 2, 1, 1,

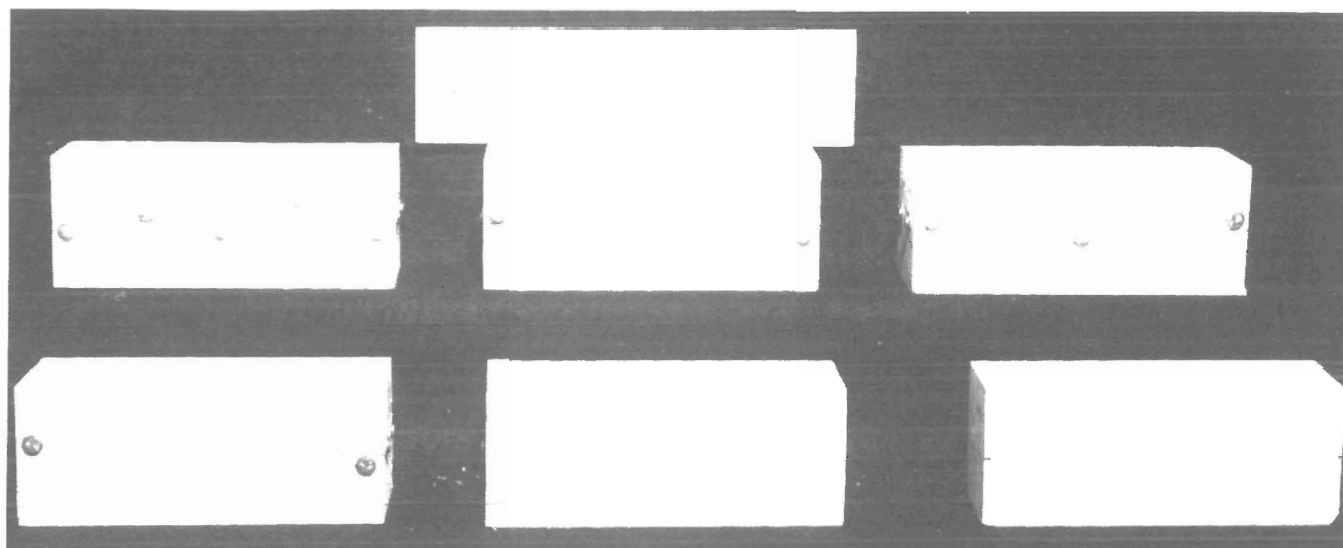
Figure 2.—Test specimens showing different bolt configurations used in experiment.

A laboratory experiment was designed and conducted to test the bolt spacing equation and the nonpreventable failure concept. In this experiment, rectangular specimens prepared from a high-strength gypsum cement were supported with full-column, grouted bolts.⁴ The specimens were 5.3 in long, 2.0 in wide, and between 2.0 and 2.1 in high. Steel bolts with bearing plates were installed in two

of the long sides of the specimens which represented the rib of a pillar that could be subjected to spalling. Two bolts were also placed in each end of the specimens to minimize the effects of end failure where the entire length of the specimen could be used to evaluate the rib bolting. Figure 2 shows the bolt configurations where the bolt spacing was 0, 0.83, 0.63, 0.42 and 0.21 bolt per inch. The specimens were loaded in compression to the ultimate strength of the material and then deformed further until a specimen strain of about 4.5 pct was achieved.

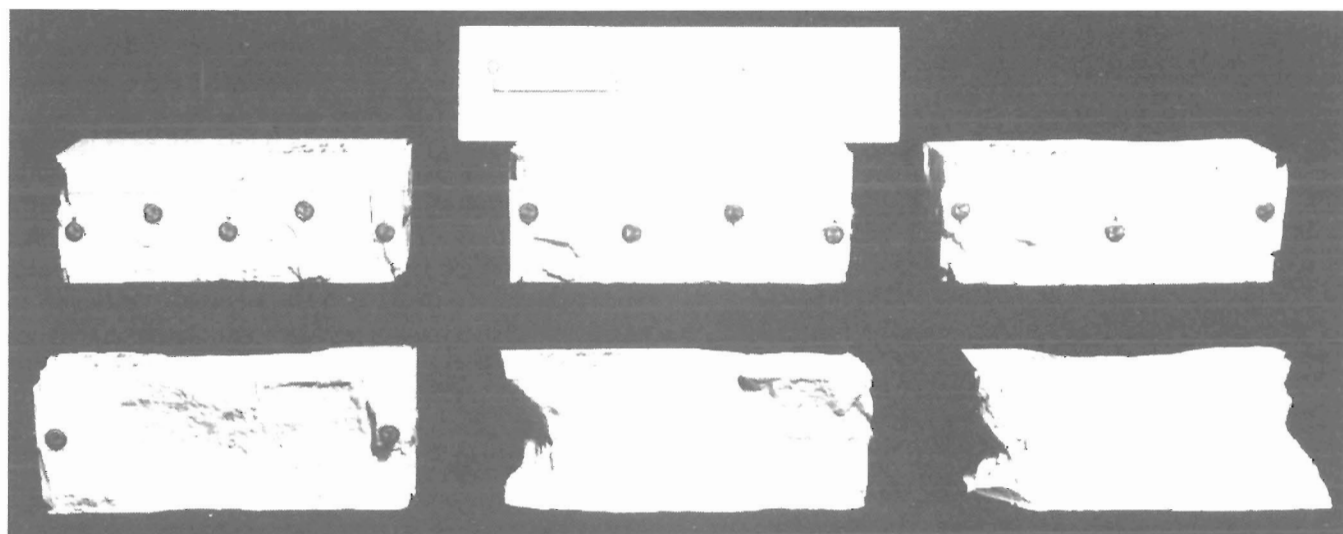
Figure 3.—Unsupported and supported test specimens.

At this strain level, 100 pct of the surface of the unsupported specimens spalled. Figure 3 shows specimens after testing for each bolt configuration. The maximum

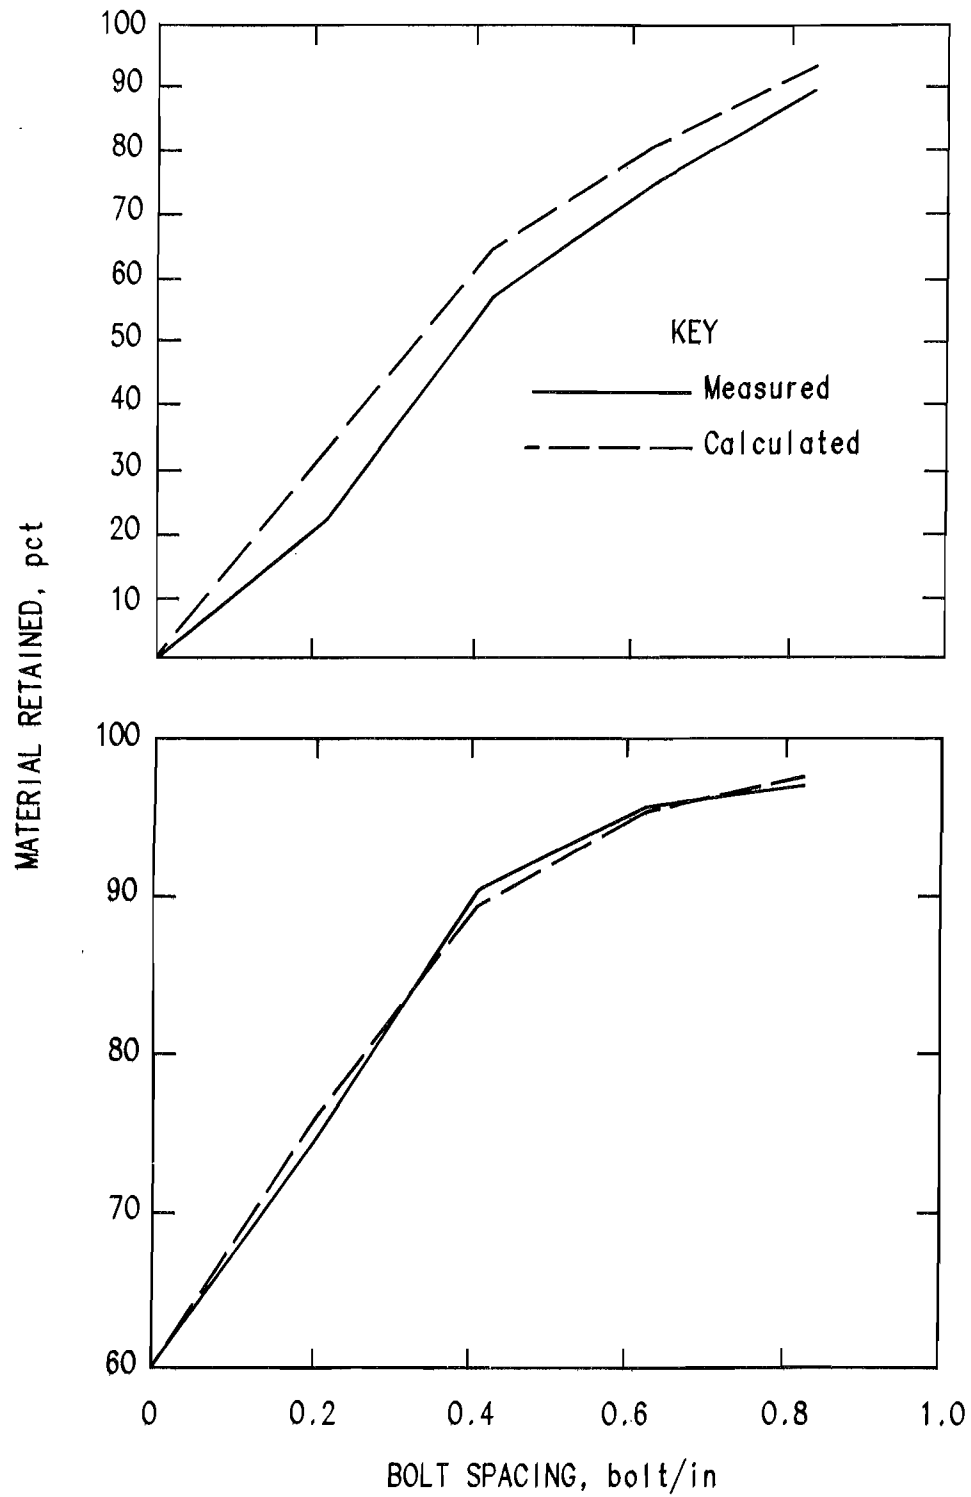
Figure 4.—Percentage of material retained by line length (top) and weight (bottom).

Figure 4 (top) shows the percent of material retained by line length along the specimen, and figure 4 (bottom) shows the percent of material retained by weight measured

in the experiment and calculated from the equation.⁵ The calculated material retained closely follows the trend of the measured values. At each bolt spacing there was no statistical difference between the measured and calculated

amount of material retained. Statistical equations of this type, therefore, accurately predict the material retention for a given bolt spacing. Also, the results based on the equation strongly indicate that the slab or failed material size (width) is an important parameter in designing the support system.

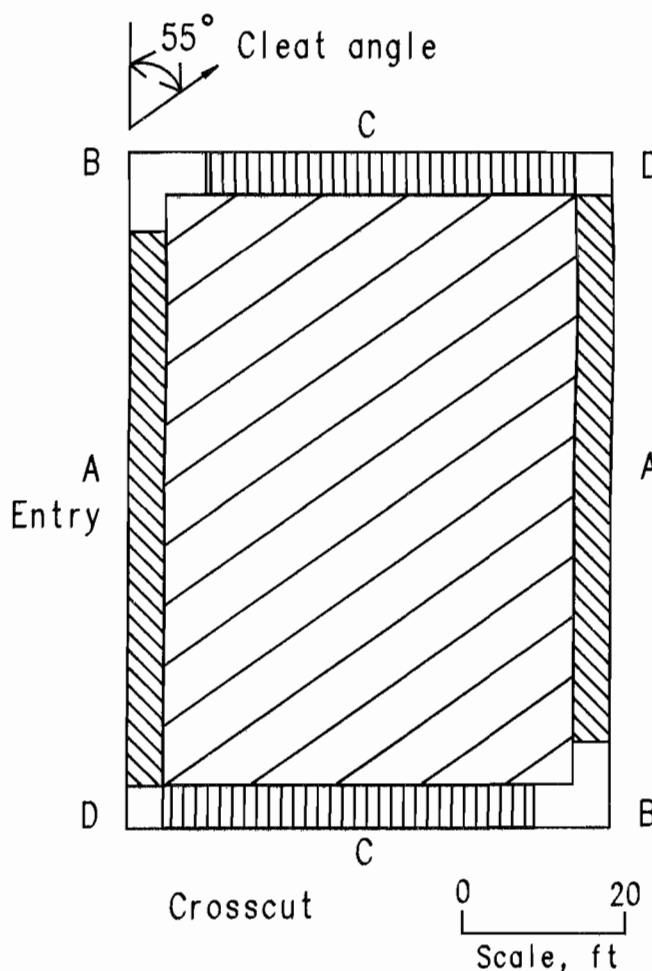
Figure 5.—Cleat orientation with respect to pillar and four different failure zones A, B, C, and D.

The support system consisted of 4-ft, full-column, grouted bolts. The bolts were placed down a line along the center of the rib at 4- to 5-ft centers. A strong unidirectional cleat exists in the mine; in the panel where rib bolting was conducted, the cleat direction is about 55° off the direction of main entries. Pillars in the section are 100 by 60 ft, and the mining height is between 8 and 10 ft. Figure 5 shows the relationship between the pillar and the cleat direction. Four zones (A, B, C, and D) around the pillar are indicated where different material failure patterns and various sizes of failed material develop. The variation in the failed material is the result of the cleat and the mining or stress-induced fractures (2). The zones include two different types of failure patterns for the ribs and for the corners.

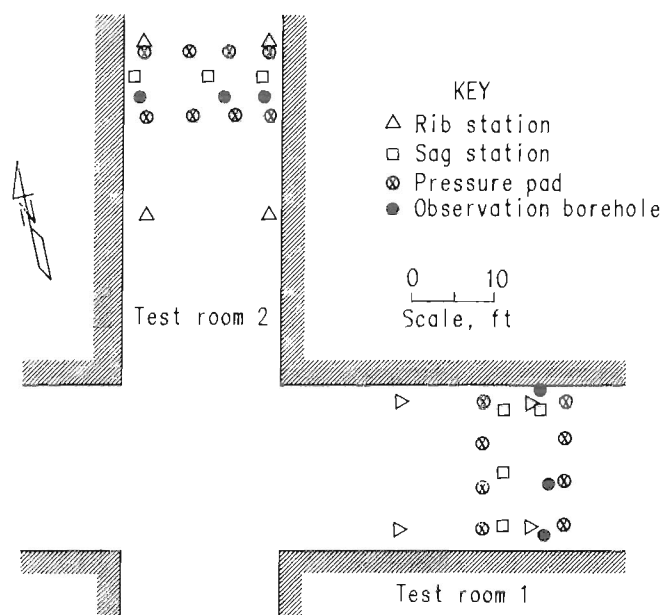
Figure 10.—Experimental instrumentation configuration of test rooms 1 and 2.

A field investigation was performed at the Cyprus Orchard Valley Mine to determine the effects of rib sloughage on the stability of the roof. The mining method in the test area is a room-and-pillar configuration. The test site was located in an entry and an adjacent room, under approximately 720 ft of cover. To measure the loads generated on the primary support system and monitor the subsequent roof movements, 16 Goodyear⁶ pressure pads were placed between the bearing plates and 8-ft threaded Dywi Dag roof bolts, and 6 differential sag stations were installed to monitor the roof movement. To observe the pillar sloughages and movements, two techniques were applied. The first method involved hanging a plumb-bob line from a predetermined location and measuring the distance between the line and the coal pillar at the same position for repetitious readings. The second method was a photographic technique. A straight

white polyvinyl chloride (PVC) pole was attached to a predetermined location and permitted to hang vertically to the ground. A camera was set up under a plumb-bob, to assure the same location, approximately 50 ft away from the pole. Without any additional light sources, a cap lamp was used to paint the pole while the shutter on the camera was opened for 15 s. This provided an excellent profile of the pillar and at the same time permitted distances to be determined between the vertical pole and the ribline. Additionally, observation boreholes were placed in the immediate roof and in the pillar to observe any separations or partings. The purpose of the field instrumentation and the rib monitoring program was to establish the effect, if any, of rib sloughage on the primary roof support system and determine the subsequent behavior in the immediate roof. The test site instrumentation (fig. 10) was read and evaluated five times in an 8-month period.

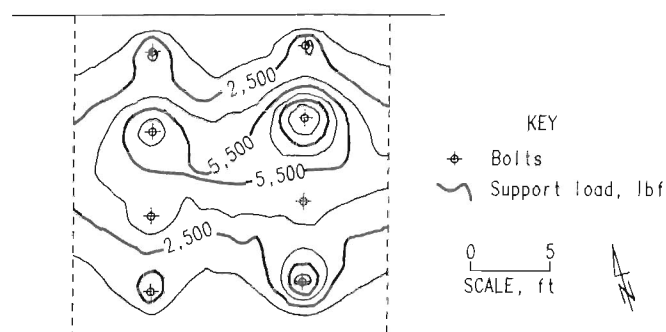
Figure 11.—Isopleth of support loads 42 days after support installation in test room 1.

The test area was monitored and evaluated 42 days after the initial installation. The loads in test room 1 ranged from 3,760 to 12,052 lbf, with the average load being 6,646 lbf, or an increase of 536 lbf. The measured loads in test room 2 ranged from a minimum of 2,990 lbf to a maximum of 9,778 lbf. The loads generated on the roof bolts in this room had increased an average of 222 lbf. During this same period, the ribs in test room 1 underwent extensive sloughage on the south side of the test room. The initial span in the room was 18 ft 11 in and the span, 42 days after installation, had increased to 20 ft 11 in. This is an increase in the visible span of 11 pct. Drill holes placed in the pillar indicated that the

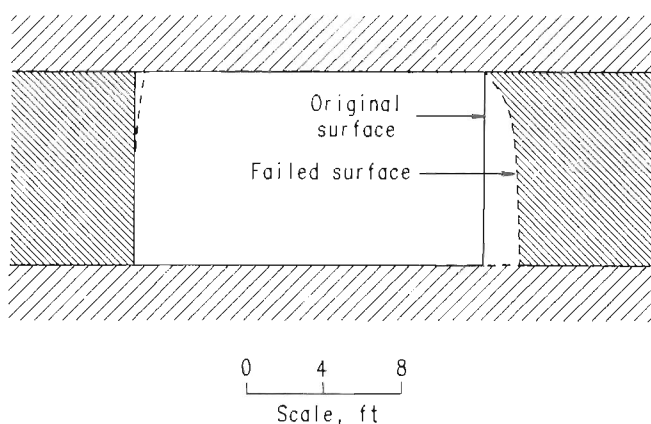
Figure 12.—Initial and 42-day rib profile for test room 1.

yield zone of the pillar extended an additional 14 in on both sides. This increase would surmise an effective span increase to 23 ft 3 in or 23 pct. To assist in the visualization of the existing support behavior, figure 11 shows a support load isopleth. Figure 12 shows the initial rib profile and the subsequent profile 42 days after the initial installation. The ribs in test room 2 remained stable with very little or no signs of rib movement. In fact, the ribs actually dilated on the east rib approximately 3 in. Representation of the data from test room 2 is shown in a load isopleth in figure 13. The observation boreholes drilled in the pillars showed no separations or parting to a hole depth of 10 ft.

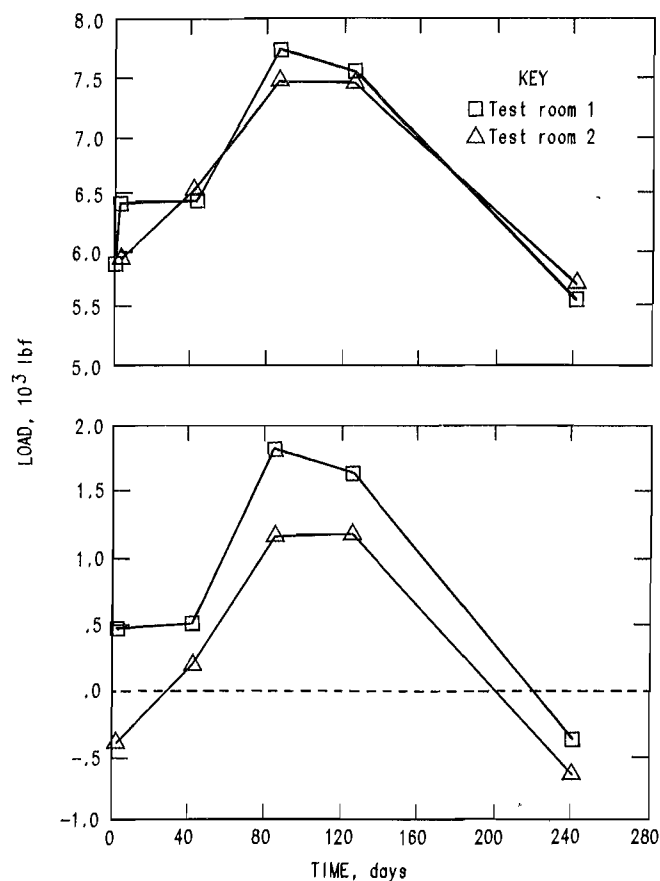
Figure 14.—Average support loads (top) and load changes (bottom) in test rooms 1 and 2 developed with respect to time.

The test site had stabilized and was not monitored for 117 days. The working face was approximately 1,500 ft inby. The loads generated on the primary roof support in both test areas had dropped approximately 35 pct in both areas. The average loads for test room 1 and test room 2 were 5,565 and 5,691 lbf, respectively. The differential sag stations installed in the roof to monitor the strata behavior indicated that the immediate roof had undergone a complex behavior. The immediate roof had a 1-in band of a wet, soft shale that actually permitted the roof to dilate upward with respect to time. The soft layer also permitted differential movements which makes the explanation complex and far beyond the scope of this report. However, it should be pointed out that the support behavior and subsequent roof movements in test room 1 and test room 2 appeared nearly identical. Figure 14 illustrates the average support loading patterns (top) and the change (bottom) in loads for each of the test rooms.
